June 28, 2019
File No. 262018.063

Subject: Department of Natural Resources Washington Geological Survey,
School Seismic Safety Assessment Project, Contract No. AE 410 -
Seismic Evaluation for **South Whidbey School District**

South Whidbey, South Whidbey Elementary School, Main Building

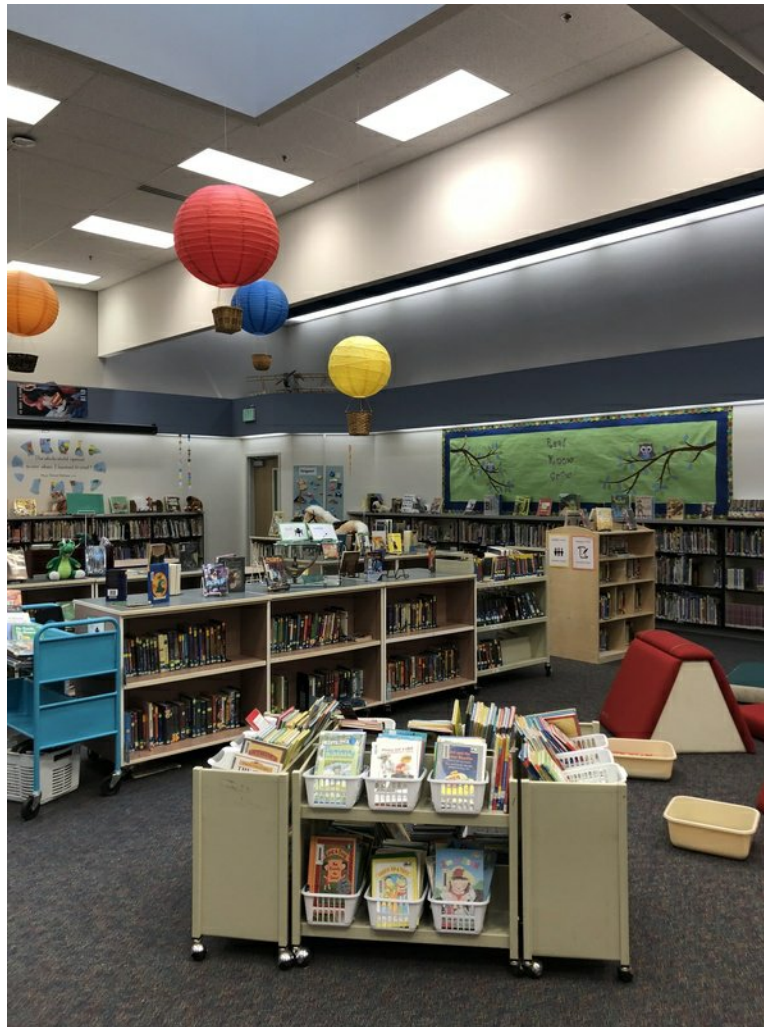
Figure 1-1. School library. No shelving or unanchored elements exceeding 6ft in height observed.

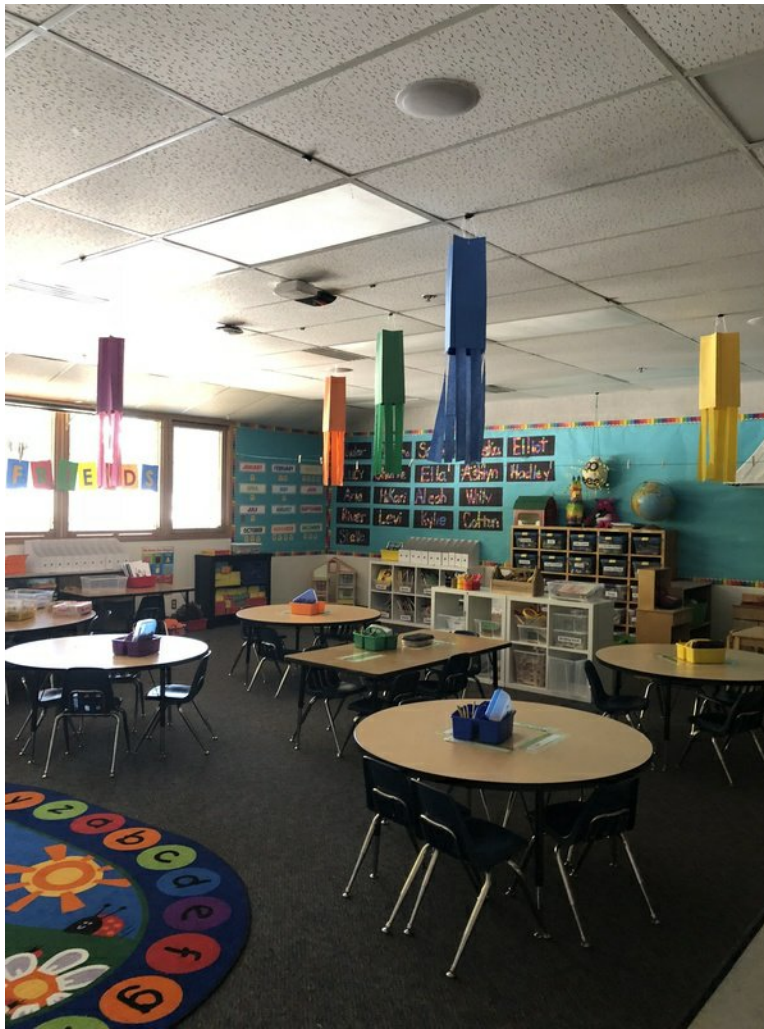
Figure 1-2. Typical classroom. No unanchored shelving or items exceeding 6ft in height observed.

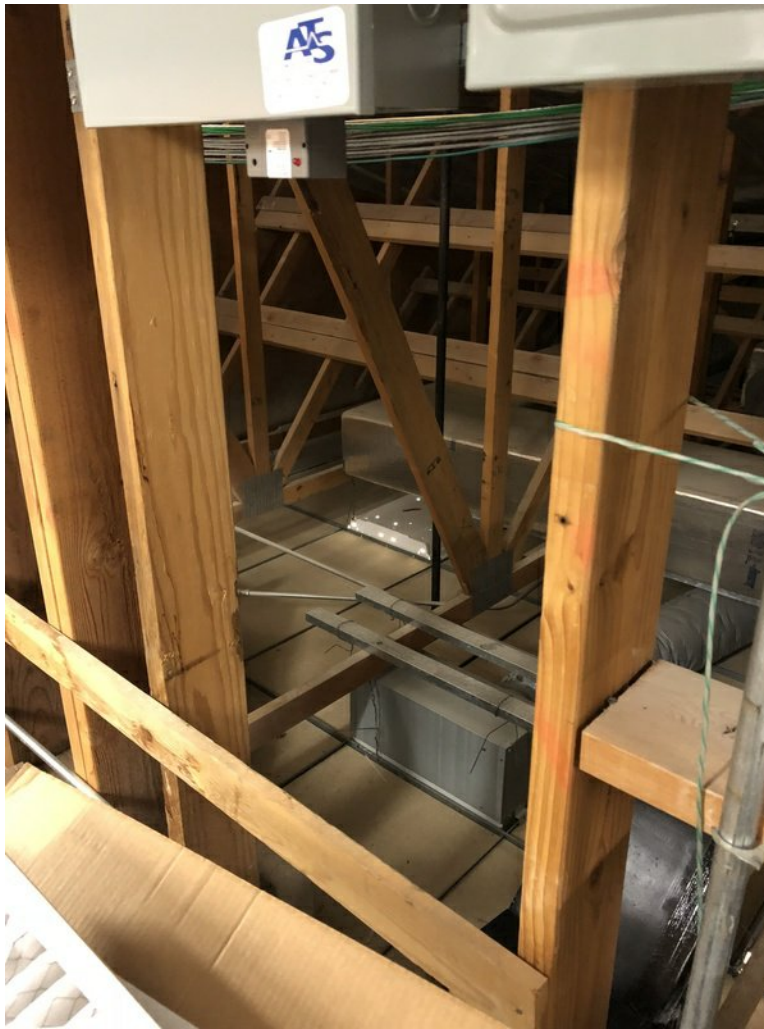
Figure 1-3. Typical drop ceiling support as seen from mechanical catwalk.

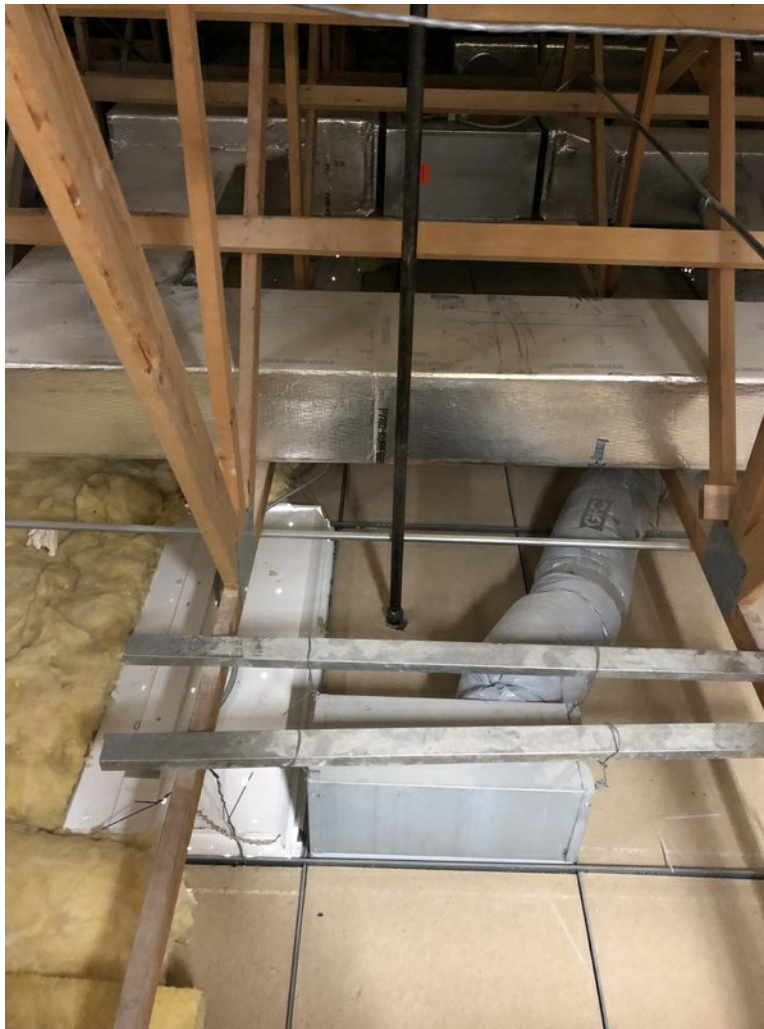
Figure 1-4. Typical fire sprinkler penetration through drop ceiling. Recommend providing larger escutcheon through ceiling to provide required clearance.

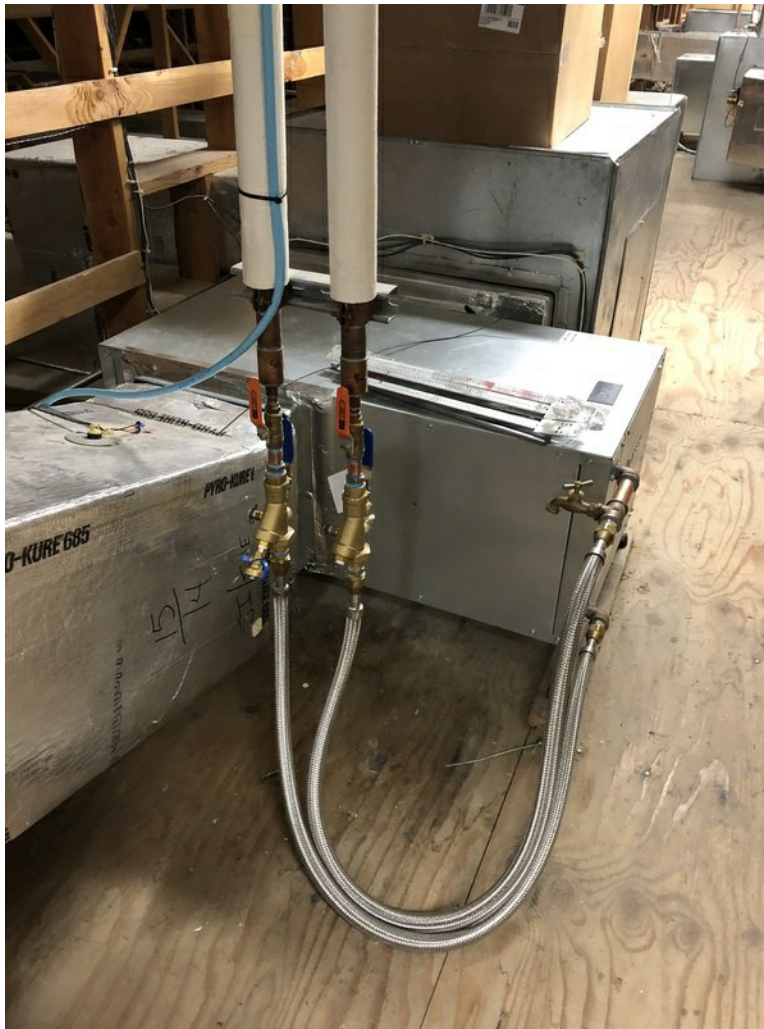
Figure 1-5. Mechanical unit featuring flexible connections. Recommend upgrading all connections to flexible pipe.

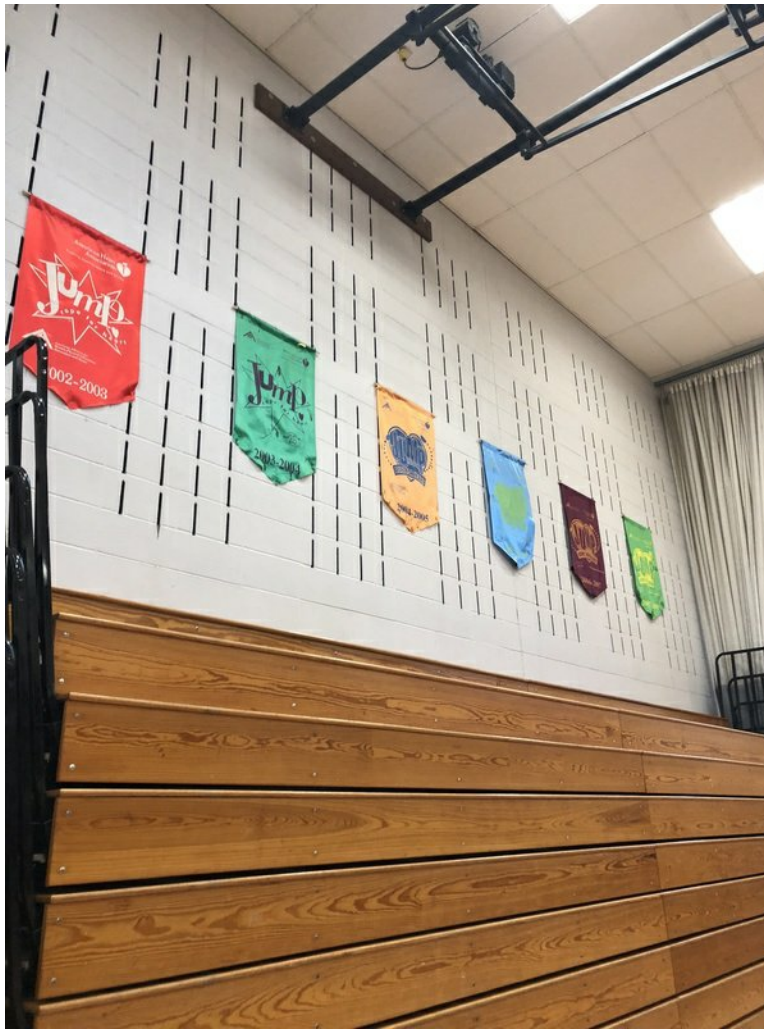
Figure 1-6. Gymnasium featuring fluted acoustical block. Recommend further study in Tier 2 analysis to evaluate capacity of shear walls with fluted block.

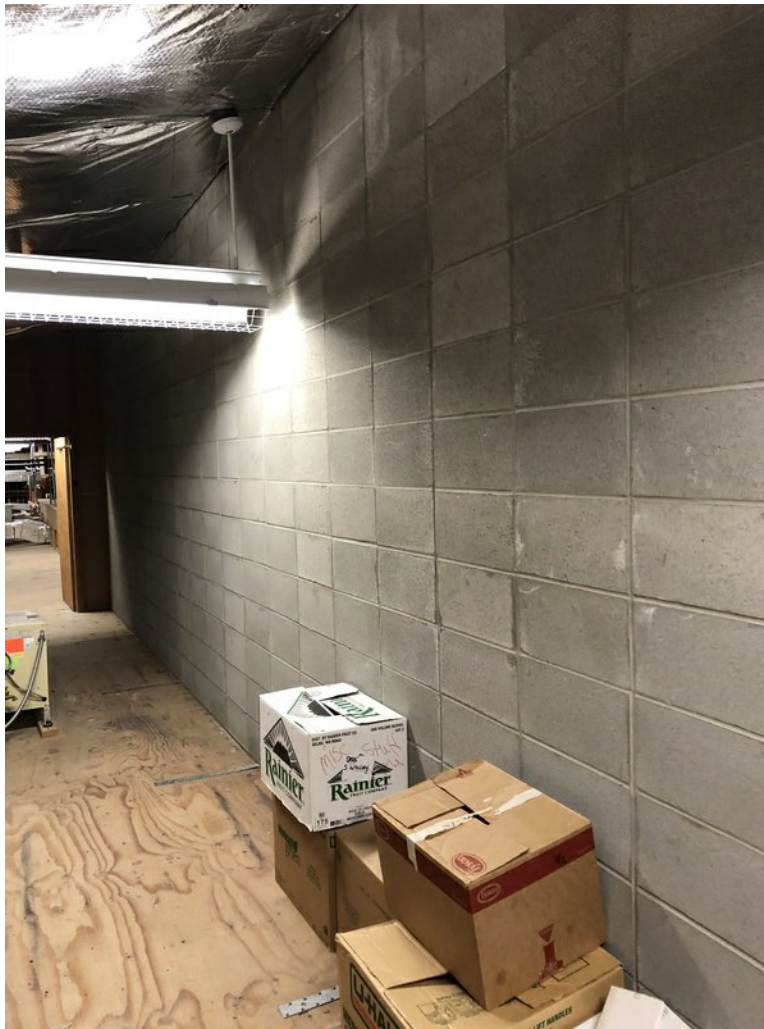
Figure 1-7. View of gymnasium masonry walls from mechanical catwalk.

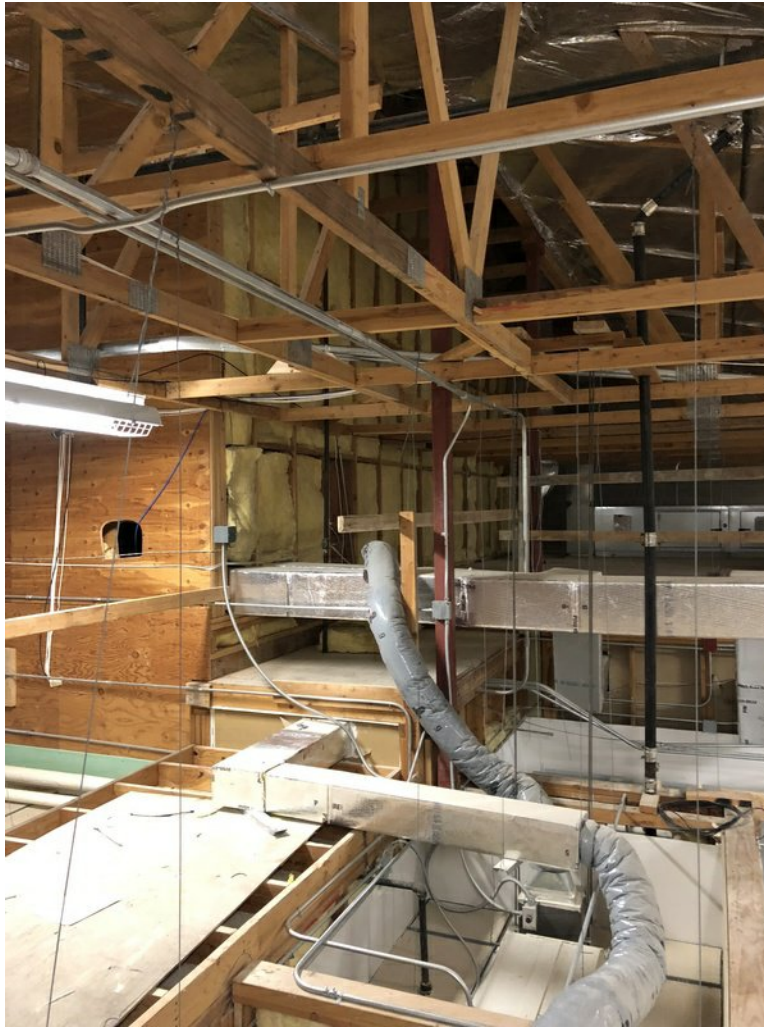
Figure 1-8. Building interior above the ceiling level.

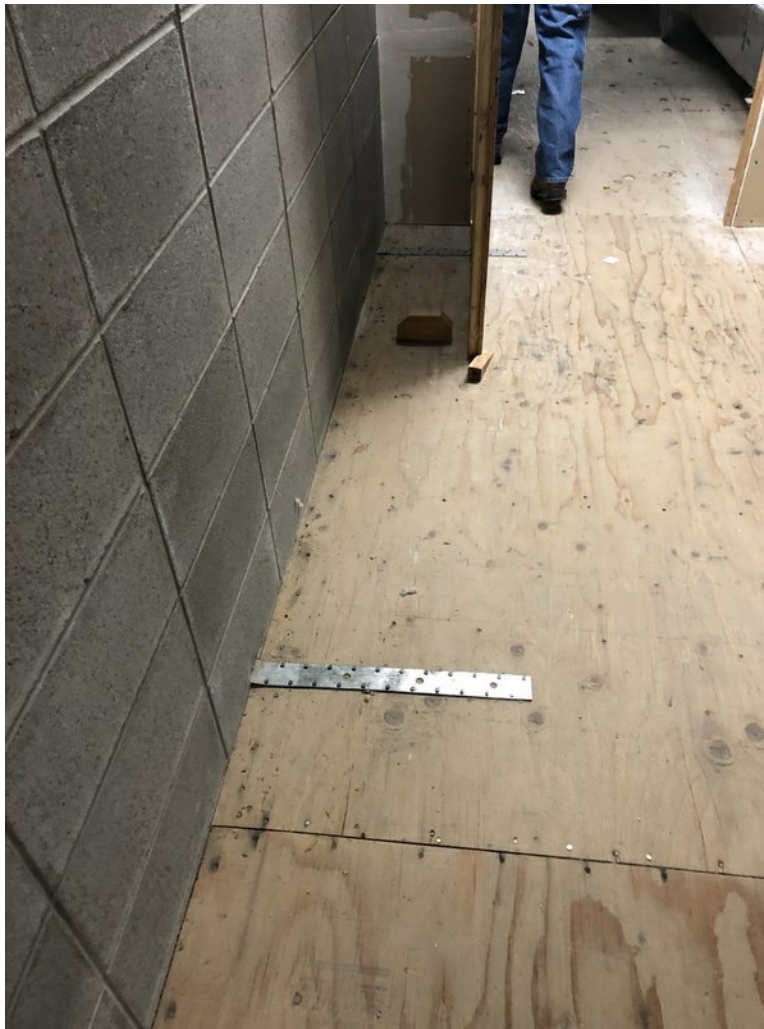
Figure 1-9. Out-of-plane bracing for masonry wall to light-frame wood diaphragm.

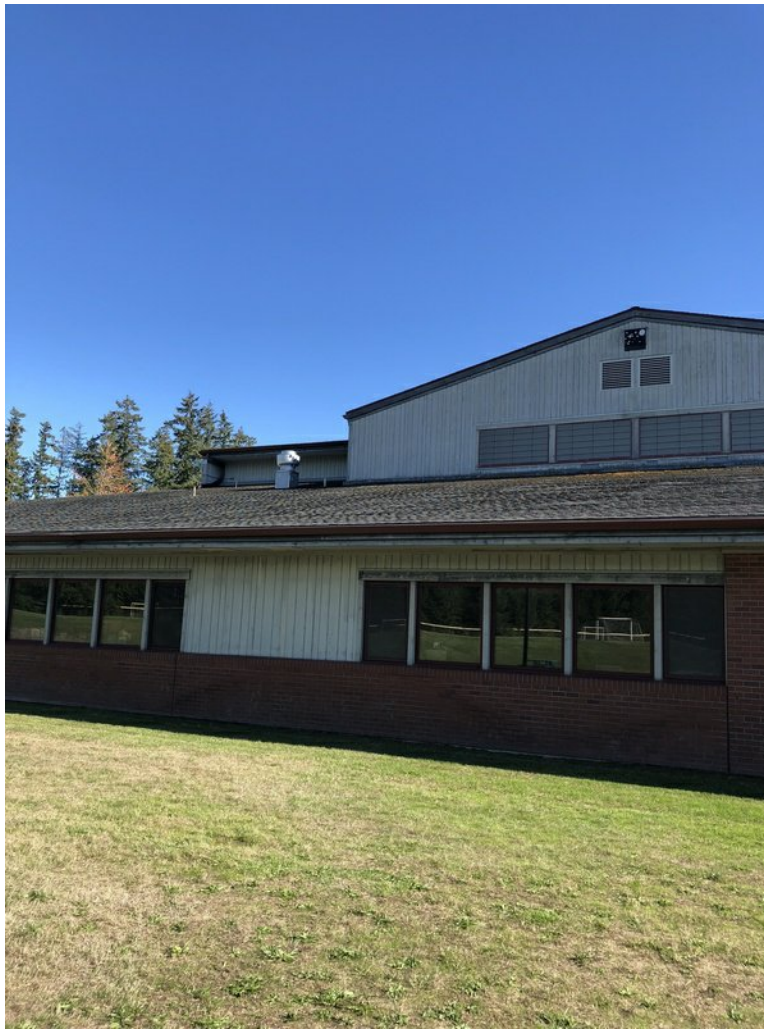
Figure 1-10. Typical exterior view of school. Brick veneer is not original to building.
